RE: September 2004 Monthly Report
1.5 Mile Reach Removal Action
GE-Pittsfield/Housatonic River Site

**GE-Pittsfield/Housatonic River Project 1.5 Mile Removal Action
Pittsfield, MA**

Figure 1
1.5 Mile Removal Action
Site Map
September 2004 Monthly Report

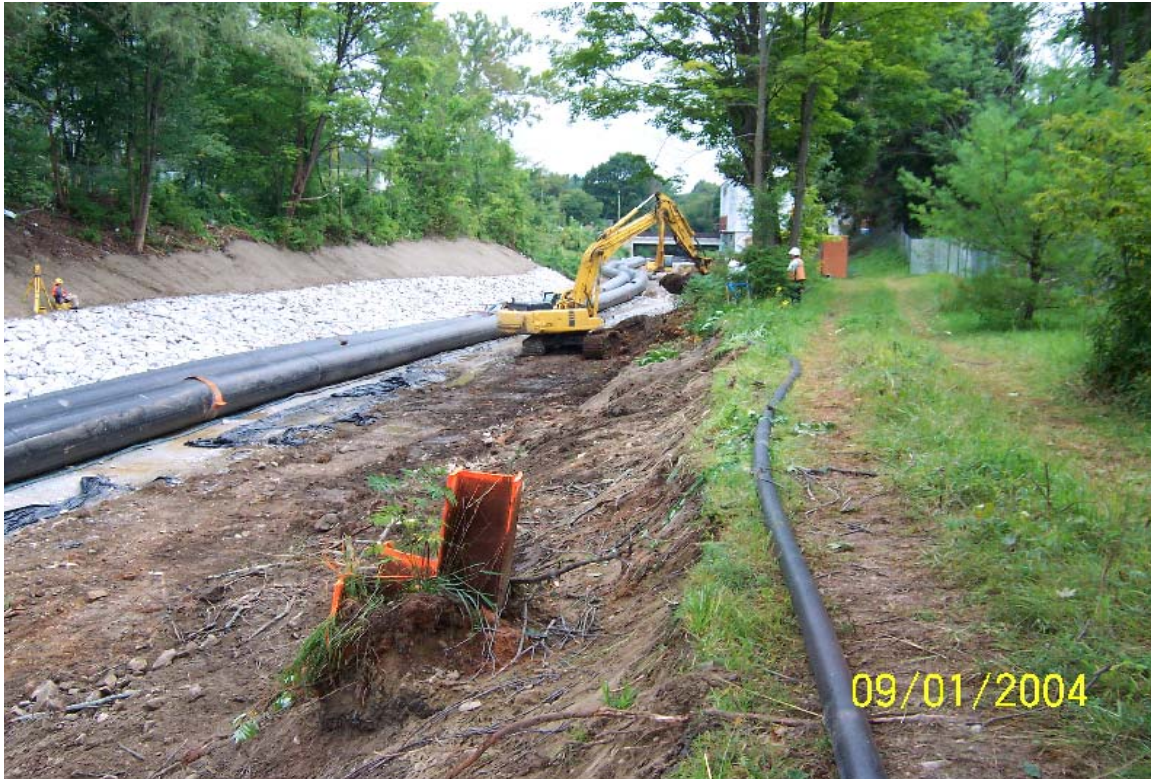
Photograph 1 - Gabion Baskets Removed in Cell 18W

By the end of August 2004, the excavation of reno mattresses, the gabion baskets, the coconut logs and riverbank soil in Cells 18W and 19W was initiated. During the first week of September, excavation activities in Cells 18W and 19W continued. The excavated material was placed into an off-road articulated dump truck (ADT), which transported and dumped the material into a roll-off box located in the river channel in Cell 20. The material was then loaded into dump trucks by a long stick excavator located on the load out area on Parcel I7-21-3. The gabion basket and the riverbank material uncharacterized for off-site disposal was transported to Area 64B and Area 64C stockpile management areas. The TSCA material was transported to Area 64A. (See Table 1 for quantities of material generated in the month of September 2004 and Table 2 for quantities of material generated to date.)

Once the gabion basket and riverbank soil excavation activities were completed in Cell 18W and 19W, the riverbed excavation was initiated in Cell 18W. First, the cobble material was excavated from Cell 18W river bottom. The excavated cobble material was placed into an ADT which transported and dumped the material into a roll-off box located in the river channel in Cell 20. The material was then loaded into dump trucks by a long stick excavator located on the load out area on Parcel I7-21-3 and hauled to Area 64E stockpile management area.

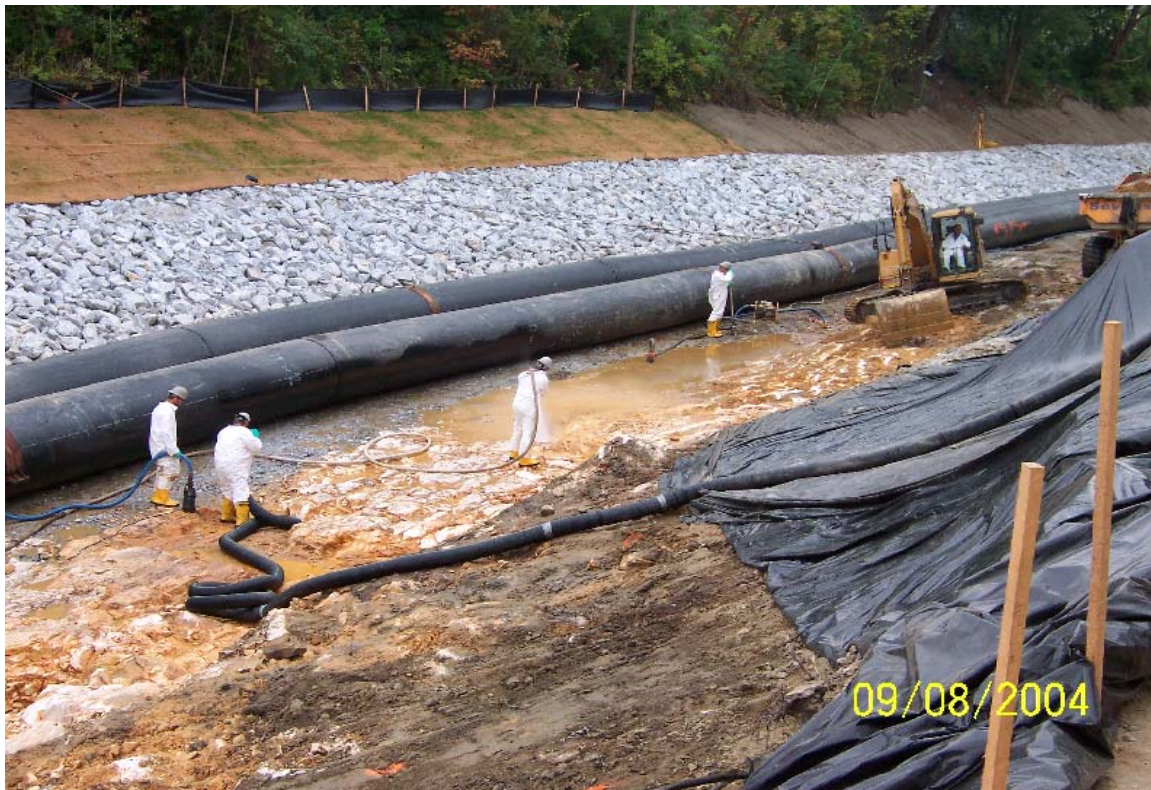
Photograph 2- High Pressure Washing/Vacuuming of Bedrock in Cell 18W

To advance the completion of Cells 18W and 19W and with the hurricane season under way it was decided that the riverbed was to be inspected and approved for backfilling as the power washing progressed downstream. Therefore the upstream sections of Cell 18W would be backfilled while the downstream portion of Cell 18W was power washed. As the riverbed power washing progressed downstream of Cell 18W, the excavation verification survey was completed, backfill grade stakes were installed and the riverbed and riverbank backfilling activities were initiated in the upstream end of Cell 18W.

Once the dewatering was completed, the high pressure bedrock power washing and bedrock vacuuming was re-started in Cell 19W. All water generated during the power washing was diverted to the water treatment system. The residual sediment from the bedrock was removed by the vacuum truck and subsequently transferred to the water treatment system modutank. The more significant amounts of non-TSCA sediment were removed by the small track excavator and transported to Building 65 stockpile management area. The excavation and power washing activities were completed in cell 19W. The final excavation survey of Cell 19W was also completed.

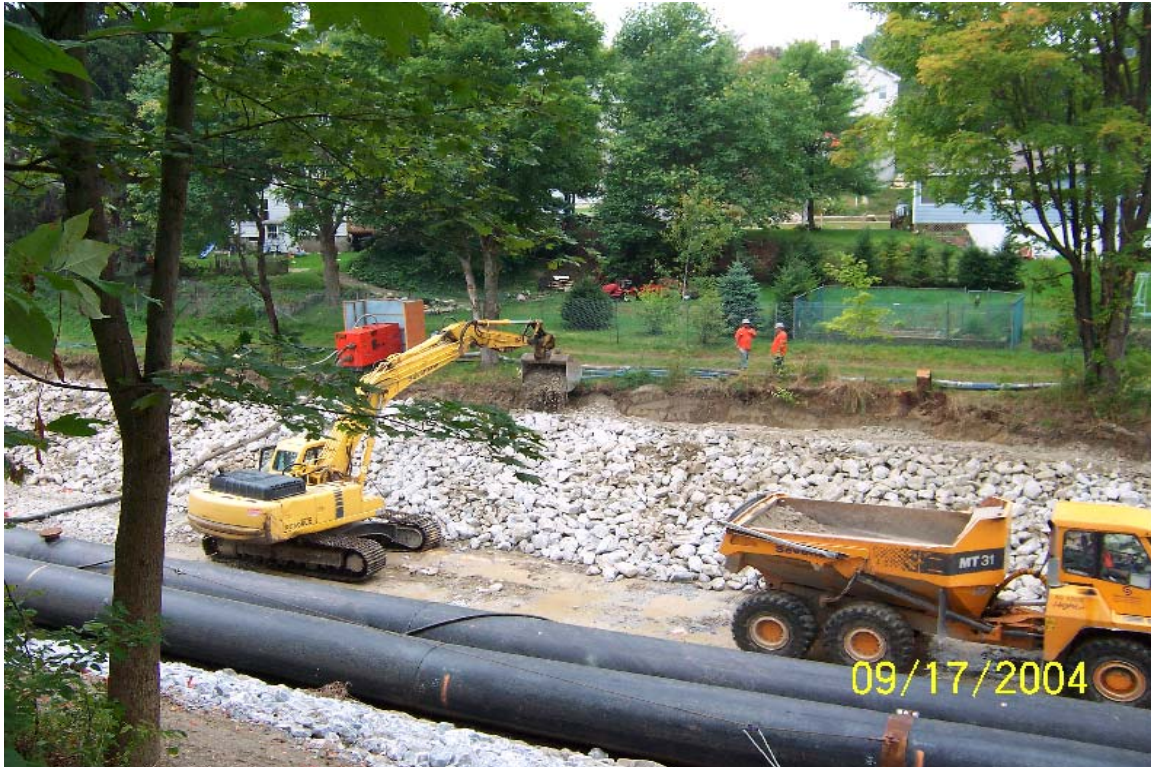
Photograph 3– Installation of Filter Stone in Cell 18W

Due to the presence of bedrock within the entire riverbed of Cells 18W and 19W, excavation depths varied. Therefore, various backfill configurations were developed to meet the design requirements. Twelve-inch riprap was placed in low lying areas and depressions in the bedrock to bring the excavated surface up to grade. Areas of the riverbed where the excavation depth was greater than 3 feet were backfilled with a layer of common fill, filter material, and 12-inch riprap. Areas of the riverbed where the excavation depth was less than 2.5 feet were backfilled with a layer of filter material and 12-inch riprap. Areas of the riverbed where bedrock was encountered at very shallow depths were either backfilled with filter material or were left with the bedrock exposed.

The lower riverbank in Cells 18W and 19W was backfilled with a six-inch layer of common fill, a six inch layer of filter material and a twenty four-inch layer of 18-inch riprap up to the 1.5 year flood elevation, which ranges between 969.0 feet to 970.5 feet. The riverbank backfilling activities above those elevations were initiated. The riverbanks will be backfilled with common fill and a six-inch layer of topsoil.

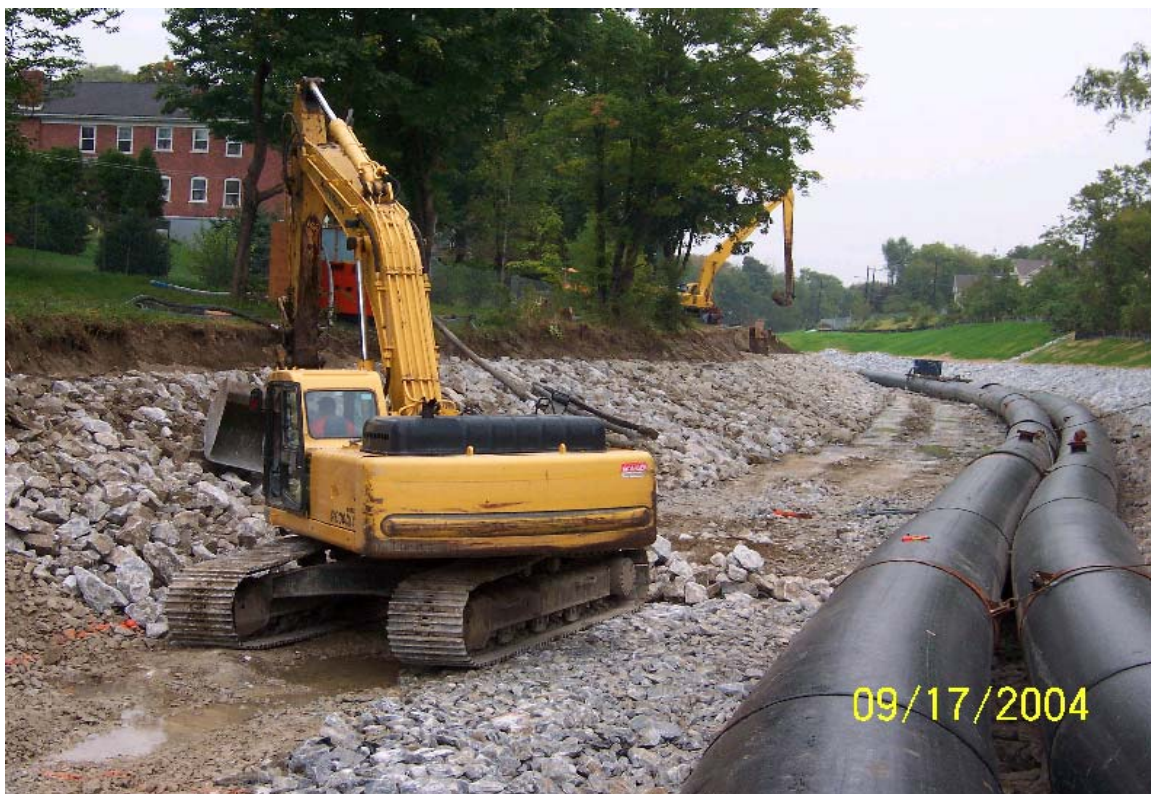
Photograph 4– Installation of 18-inch riprap in Cell 18W&19W

Also during the third week of September, the riverbed and riverbank backfilling activities were resumed in Cells 18W and 19W. The riverbed and lower riverbanks were backfilled according to the backfill configurations described above. Riverbank backfilling activities also continued in Cells 18W and 19W above the 1.5 year flood elevation. The surveyors monitored the backfilling activities in Cells 18W and 19W to ensure appropriate design backfill grades were achieved. Common fill was installed in twelve inch horizontal lifts and compacted to meet the 95% compaction requirement. Then, a minimum six-inch layer of topsoil, herbaceous seed mix and erosion control blankets were installed.

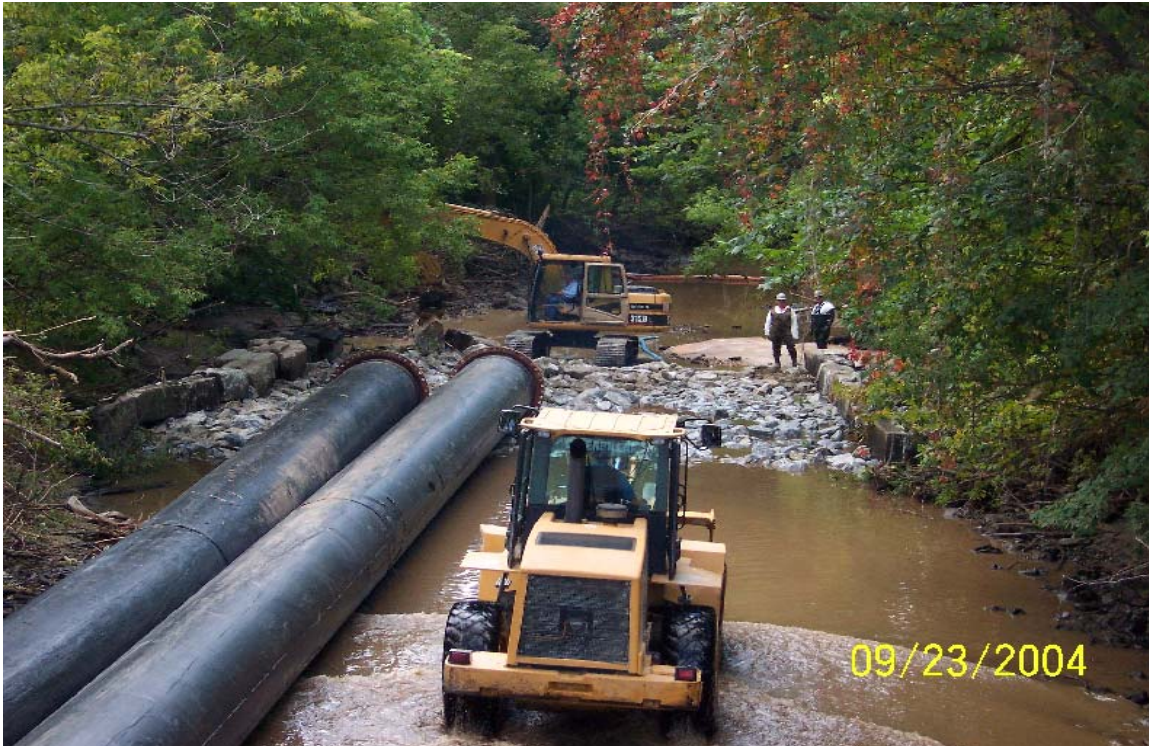
Photograph 5– Installation of Energy Dissipater downstream of Dawes Ave Bridge

A steel plate energy dissipater was relocated to the new location of the 54-inch pipe outfall located approximately one hundred feet downstream of the Dawes Avenue Bridge. Eighteen-inch riprap was also installed at the discharge point as an erosion control measure. Concrete bin blocks were placed at the toe of the riverbanks on the east and west side of the river channel to protect the riverbank from erosion from the 54-inch pipe outfall.

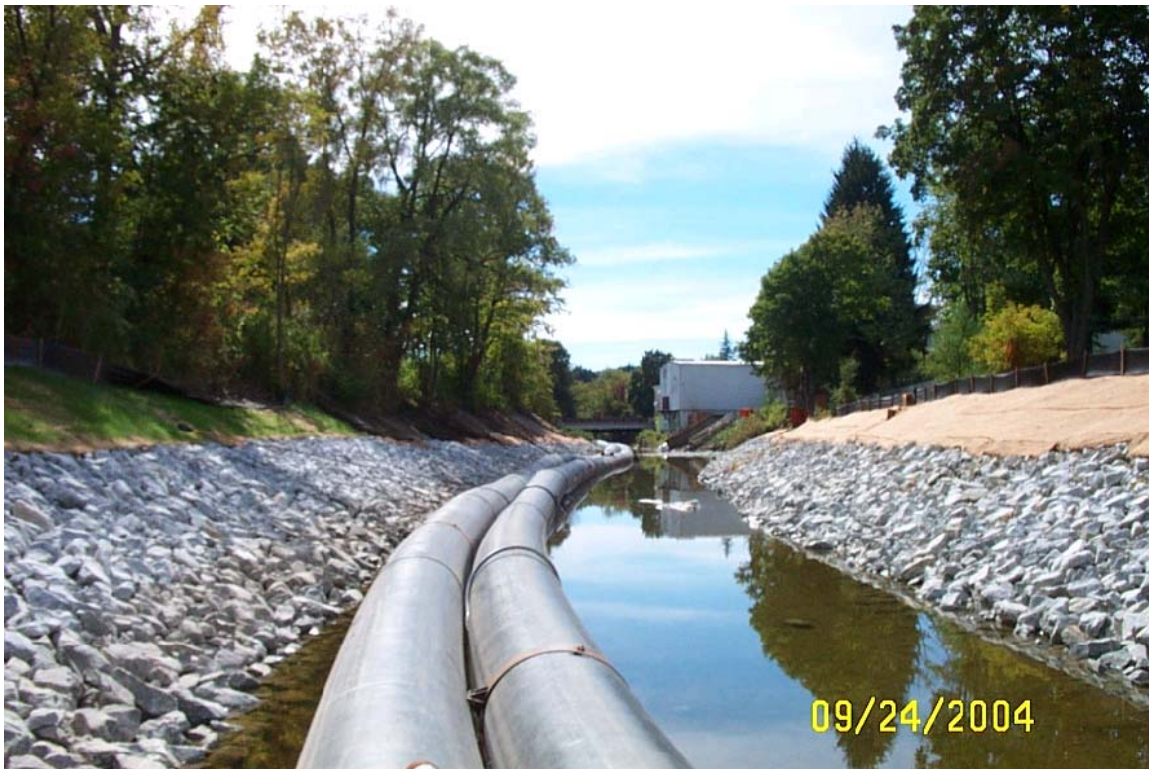
Photograph 6– Cell 18 Restored

Also, riverbank backfilling activities continued in Cells 18W and 19W above the 1.5 year flood elevation. Common fill was installed in twelve inch horizontal lifts and compacted to meet the 95% compaction requirement. Then, a minimum six-inch layer of topsoil, herbaceous seed mix and erosion control blankets were installed. Silt fencing was installed along the top of the riverbanks in Cells 18W and 19W as an erosion control measure. Once the silt fencing was installed all backfill activities in Cells 18W and 19W were concluded and the survey contractor completed the final restoration survey.

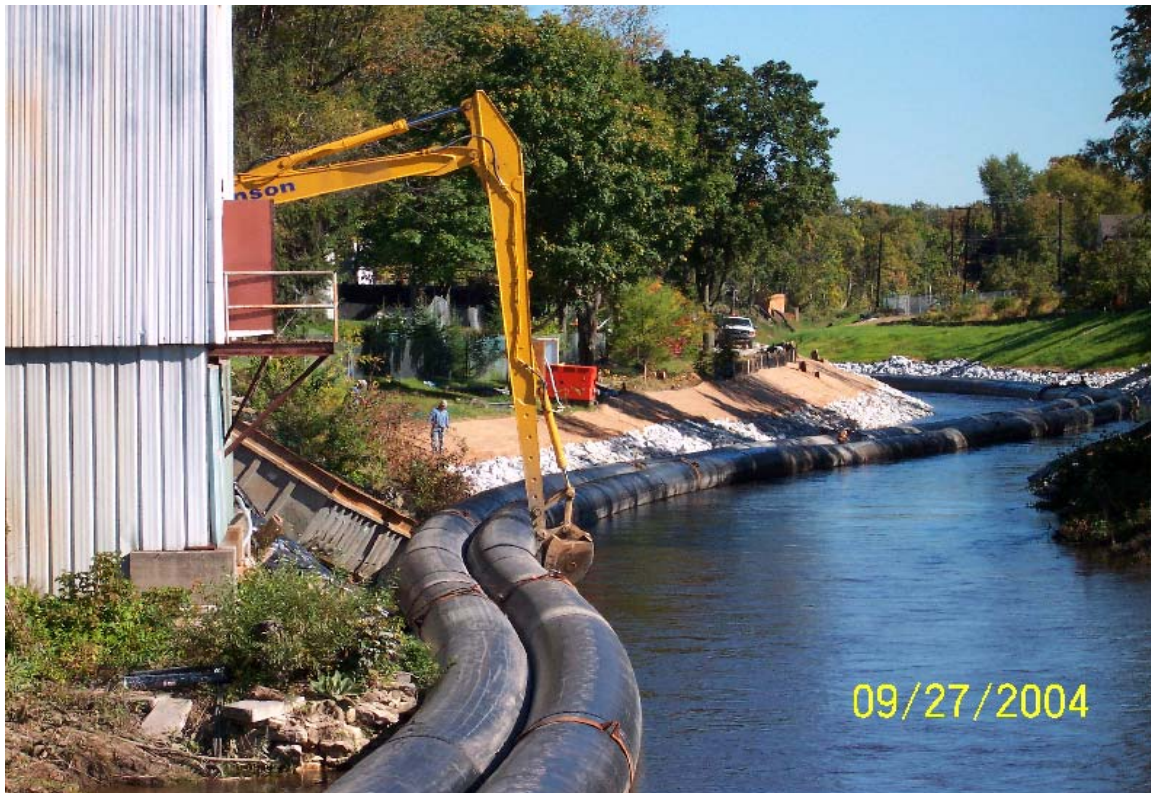
Photograph 7– Relocation of the 54-inch Pipes to the West Side of the River

During the last week of September, the two 54-inch HDPE pipes were relocated from the east side to the west side of the river channel to allow the excavation of Cells 20E, 21E and 22E. Once the relocation was completed the pipes were then reconnected to the pipe restraint system. Once the 54-inch pipe was relocated, and the stop logs were re-installed into the dam dewatering activates were initiated in Cells 20, 21 and 22. A temporary dam was constructed at the 54-inch pipe outfall to aid the dewatering of Cells 20, 21 and 22. The dam was built by using common fill, sand bags and re-enforced poly.

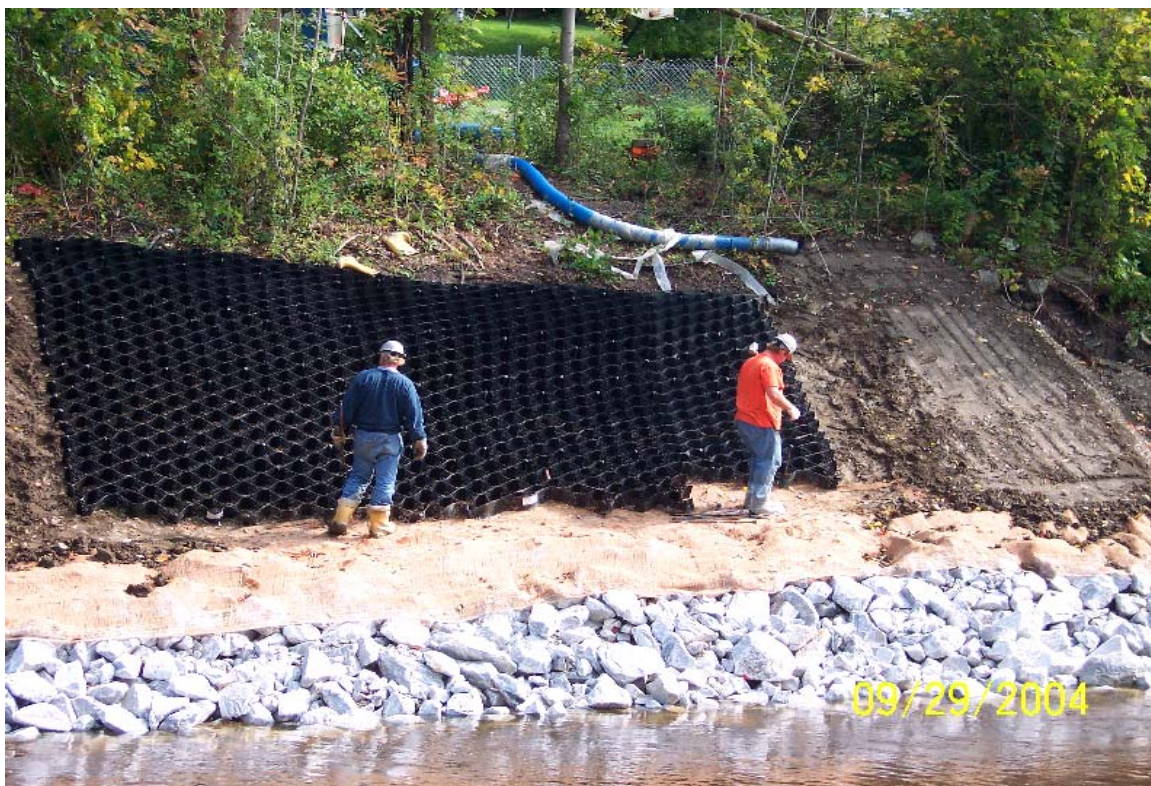
Photograph 8– Installation of Cellular Geoweb in Cell 19E

Other activities during the last week of September included the installation of cellular geoweb on Cell 19E riverbank. A portion of Cell 19E riverbank with slopes steeper than 2H:1V required cellular geoweb for riverbank stability purposes. Topsoil, herbaceous seed mix and erosion control blankets will be placed in Cell 19E geoweb at a later date.
